## Summary report

| Aircraft | Airbus Helicopters Germany EC135 T2+ | | | HB-ZUI |
| Type of serious<br>incident | Engine failure | | | |

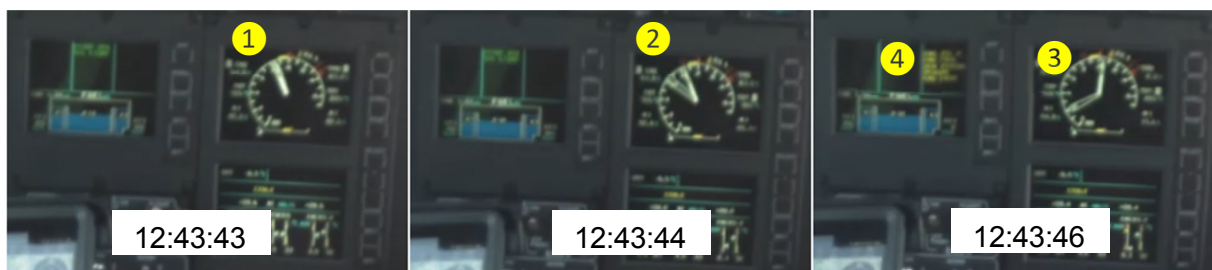
Shortly after takeoff, when the helicopter was in cruise flight, a *needle split* between the two shaft engines became visible on the combined power indicator (*First Limit Indicator* – FLI) at 12:43:44 p.m. At 12:43:45 p.m., the right engine shut down on its own. At the same time, the corresponding warnings lit up on the display system (see Figure 1).

**Figure 1:** Sequence of images from the helicopter cockpit displays: immediately before the serious incident (①); 1 second after the *needle split* first became visible on the FLI (②); approximately 2 seconds later, when the right engine had already failed (③) and the yellow warning indicators (④) became visible.

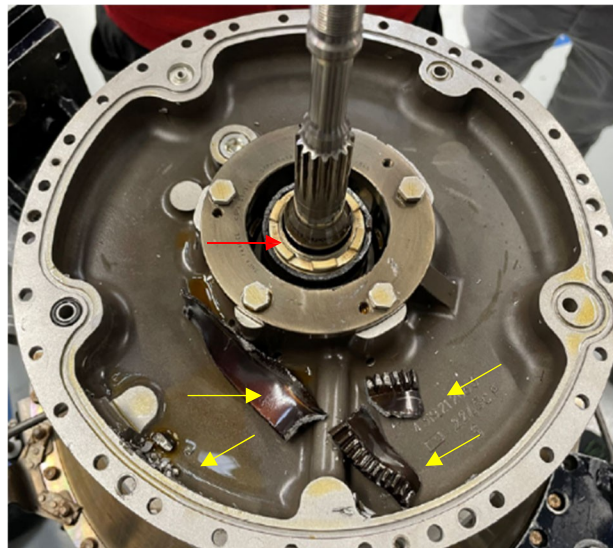
The investigation of the engine in cooperation with the French safety investigation authority (*Bureau d'Enquêtes et d'Analyses pour la sécurité de l'aviation civile* – BEA) and the manufacturer revealed that the drive gear of the *accessory drive* train was destroyed (see Figure 4). Other gears in the *accessory drive train* showed damage to the teeth.

**Figure 4:** Rear of the *accessory gearbox* with the fragments of the drive gear (yellow arrows) and its main body (red arrow)

The engine failure during climb due to the destruction of the accessory gearbox drive gear occurred unexpectedly and without any prior signs that could have been detected by the maintenance organization or the flight crew. The destruction of the drive gear meant that the fuel supply to the affected engine was no longer guaranteed, which was the cause of the serious incident.

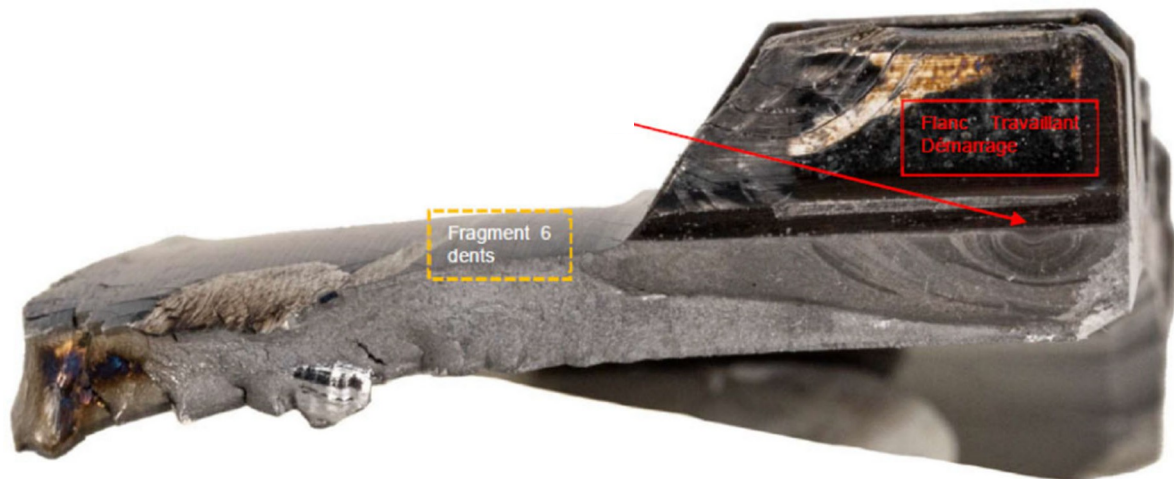
The fractures in the drive gear were examined in detail. A fatigue fracture was identified, originating at the surface of a tooth root, at the transition between the milled and cut areas during manufacture (see Figure 5).

The manufacturer was unable to explain the metallurgical singularity at the tooth root radius that contributed to the formation and propagation of the crack.

**Figure 5:** Detailed image of one of the fragments of the drive gear. The red arrow points to the starting point of the fatigue fracture. Source: Safran Helicopter Engines.

The notch that was identified as the starting point of the fatigue fracture probably occurred during the manufacture of the gear. The manufacturer cited a one-time overload during a tempering process as an additional possibility. Based on the production records, the manufacturer was able to identify two other engines that may have been affected by the same issue and initiated appropriate investigations. The gears from these two engines examined by the manufacturer showed no abnormalities.

The serious incident, in which a shaft engine unexpectedly failed during the climb, was caused by the failure of the accessory gear drive gear. The drive gear failed due to a fatigue fracture that originated in a notch in the tooth root, which was probably caused during manufacture or by a one-time overload during engine start-up. However, an overload during start-up seems unlikely, as it would have been noticed by the crew.
