## Summary report

| Aircraft | Airbus Helicopters Germany EC135 T2+ | | | HB-ZUI |
| Type of serious<br>incident | Engine failure | | | |

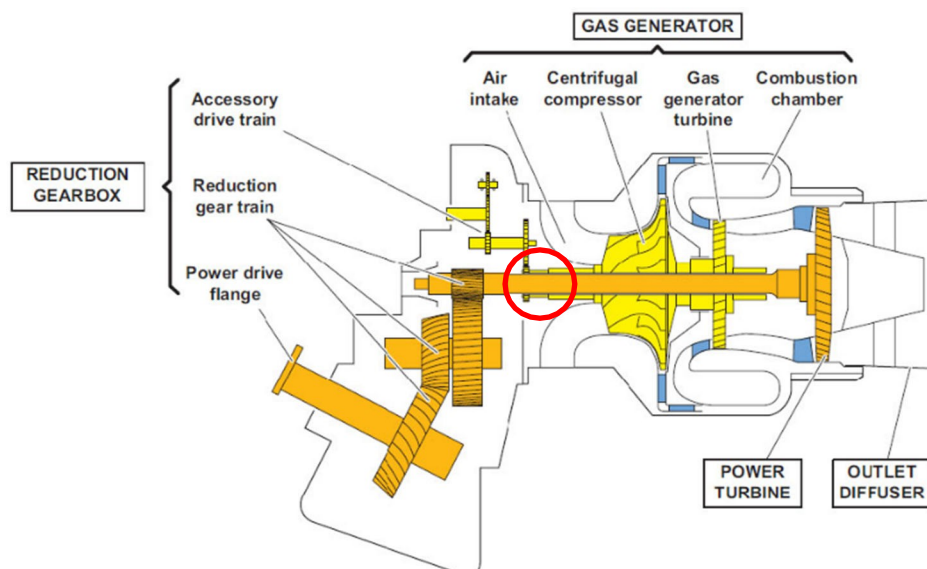
**Figure 3:** Schematic representation of an Arrius 2B2 shaft engine. The *gas generator* is shown in yellow, the *power turbine* and *reduction gearbox* in orange. The drive gear of the accessory drive train is circled in red. Source: Safran Helicopter Engines

The investigation of the engine in cooperation with the French safety investigation authority (*Bureau d'Enquêtes et d'Analyses pour la sécurité de l'aviation civile* – BEA) and the manufacturer revealed that the drive gear of the *accessory drive* train was destroyed (see Figure 4). Other gears in the *accessory drive train* showed damage to the teeth.
